LAKE NAOMI DAM

PHASE I INSPECTION REPORT NATIONAL DAM INSPECTION PROGRAM

JULY 1979

LAKE NAOMI DAM
MONROE COUNTY, PENNSYLVANIA

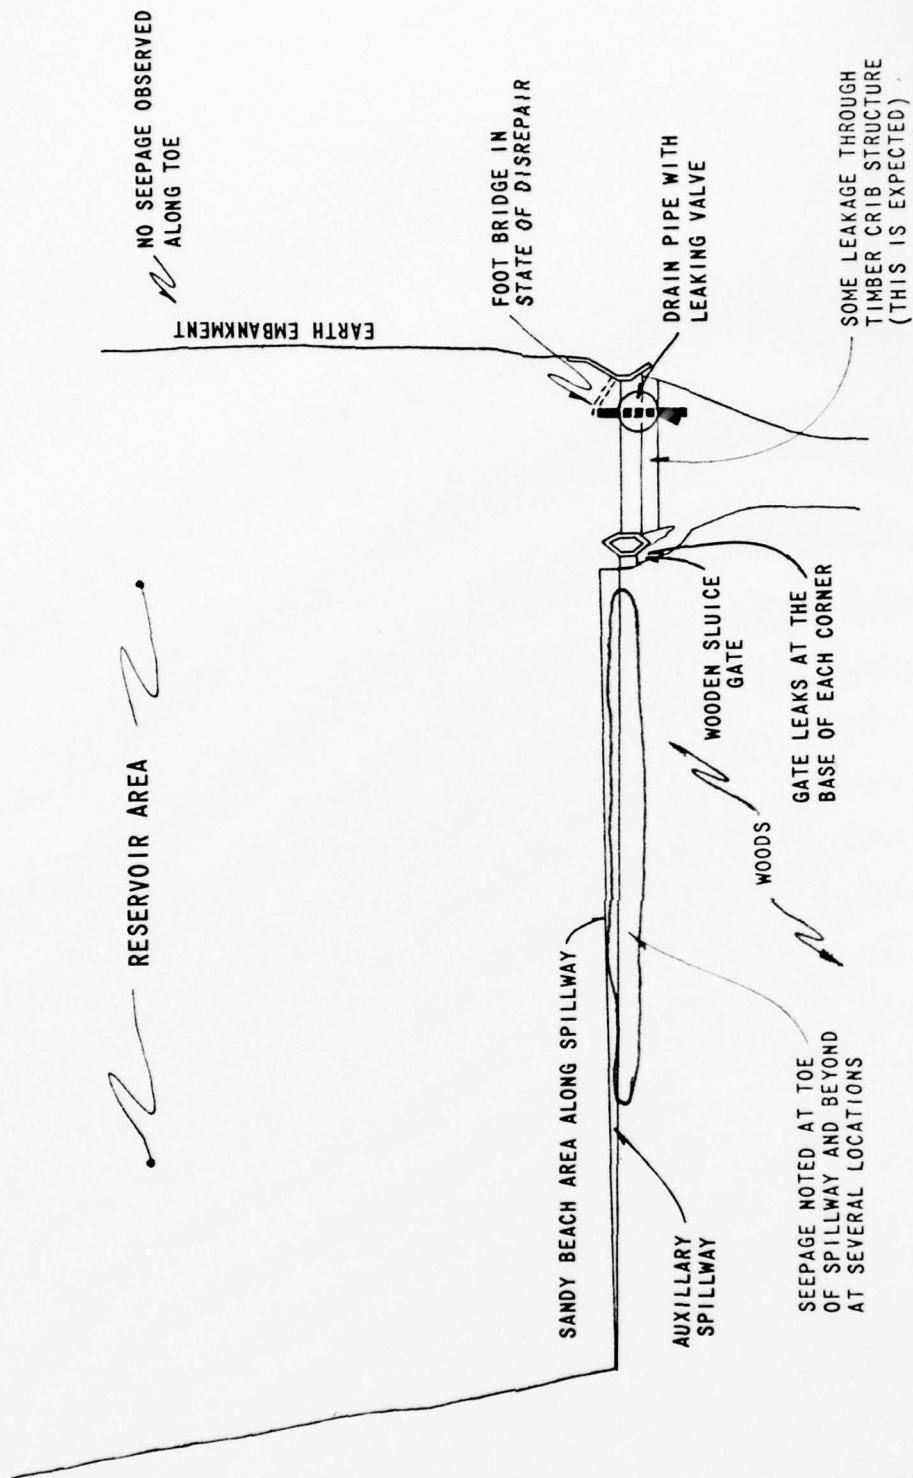
SHEET 5A OF 11

b. Dam. Vertical alignment along the crest of the embankment (dike) along Route 423 was checked and found to be reasonably uniform. The embankment appears to be in reasonably good condition and there were no signs of significant seepage. Horizontal alignments were good and the upstream riprap also appears to be in good condition. There were no surface cracks observed, and junctions between the embankment and abutment were in good condition. Although there was no seepage noted along the main embankment section, which parallels Route 423, seepage was observed downstream of the auxiliary spillway. Leakage locations are shown on sheet 5a, Appendix B.

See Sheet 5a for locations of leakage.

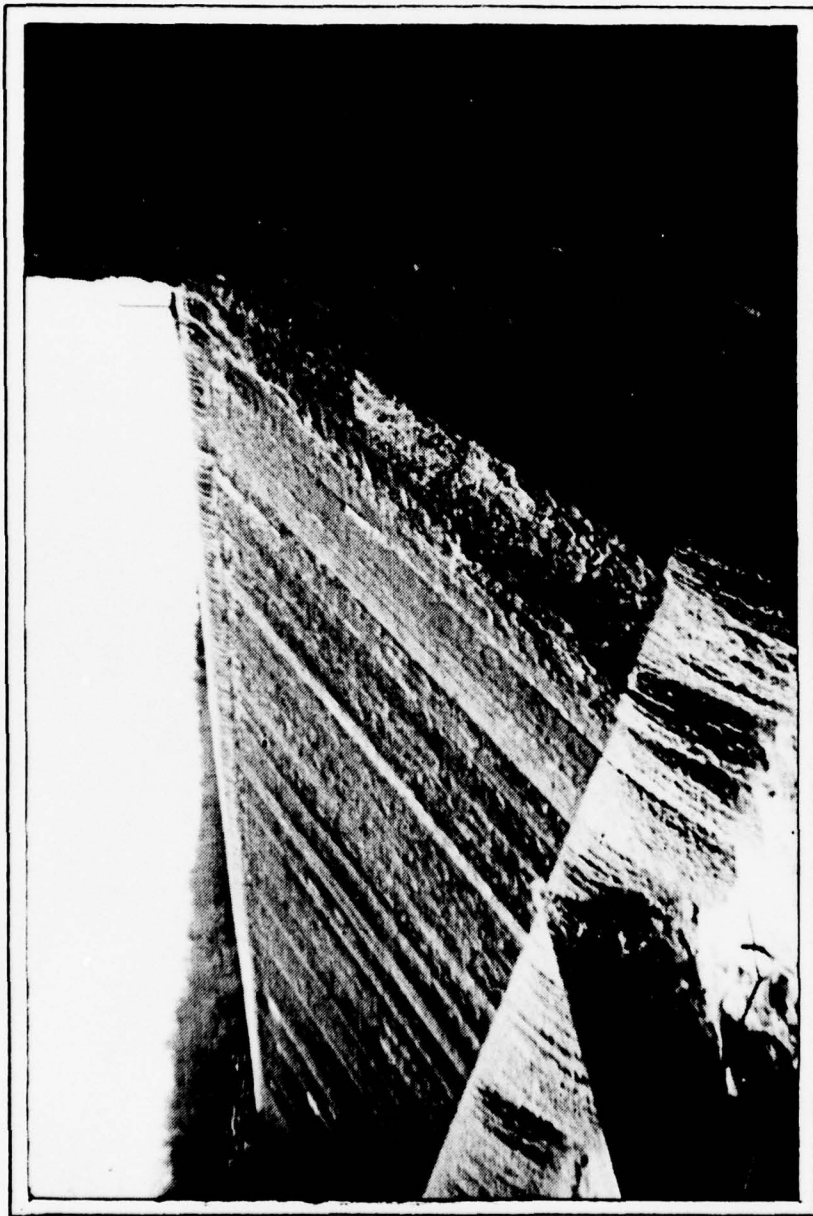
PHOTOGRAPH NO. 5

OVERVIEW OF WOODEN SPILLWAY.

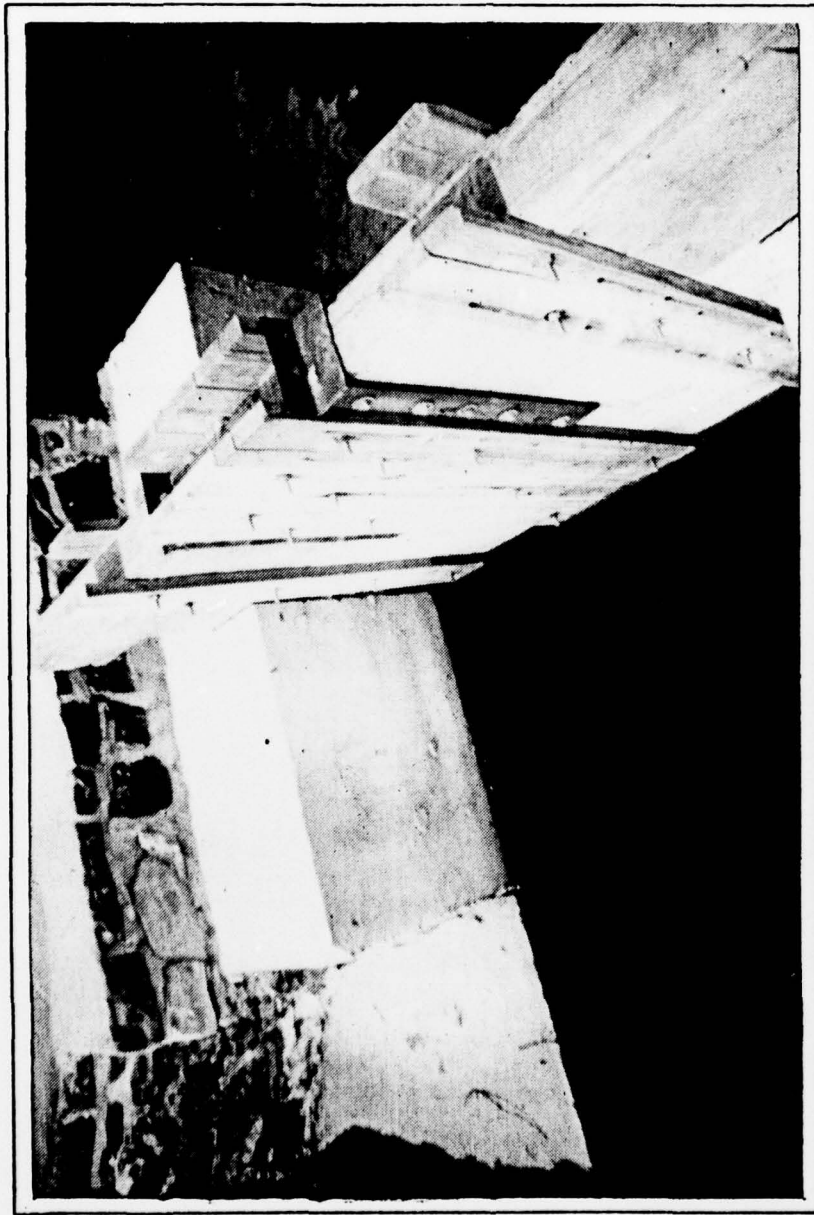
PHOTOGRAPH NO. 8

OVERVIEW OF WOODEN SLUICE GATE.

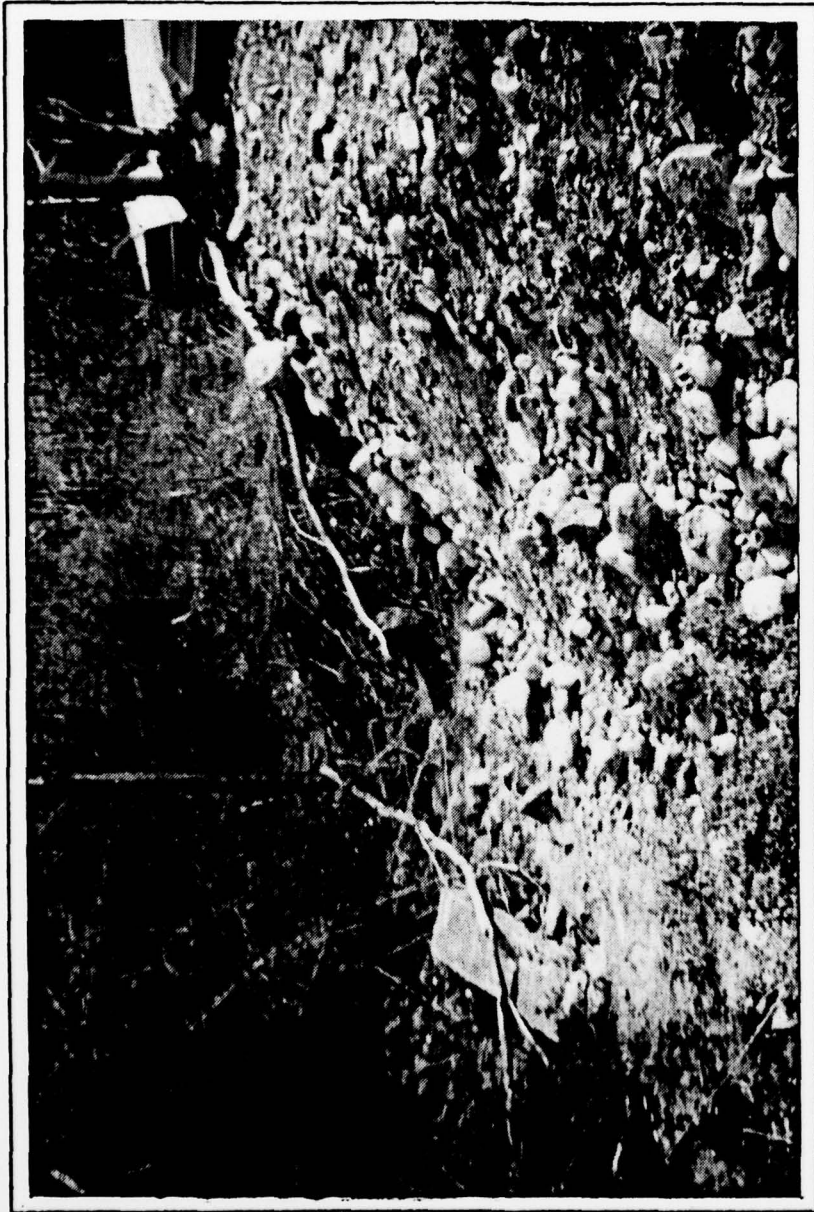
PHOTOGRAPH NO. 13

AREA DOWNSTREAM OF AUXILIARY SPILLWAY
SHOWN IN PHOTOGRAPH NO. 12. NOTE THAT
FILL WAS NOT COMPACTED OR FOUNDATION
PREPARED.

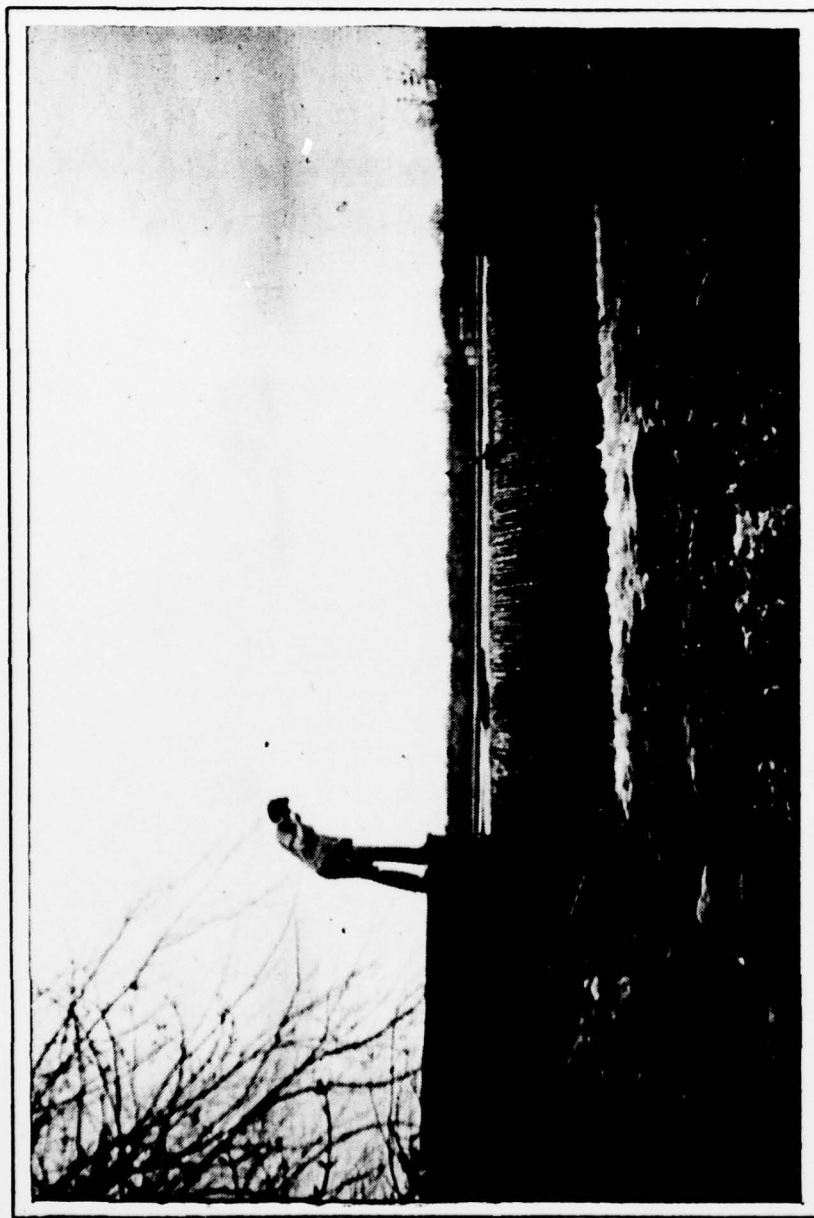
PHOTOGRAPH NO. 18

VIEW OF POCONO SUMMIT DAM WHICH DRAINS
INTO STILLWATER LAKE DAM.

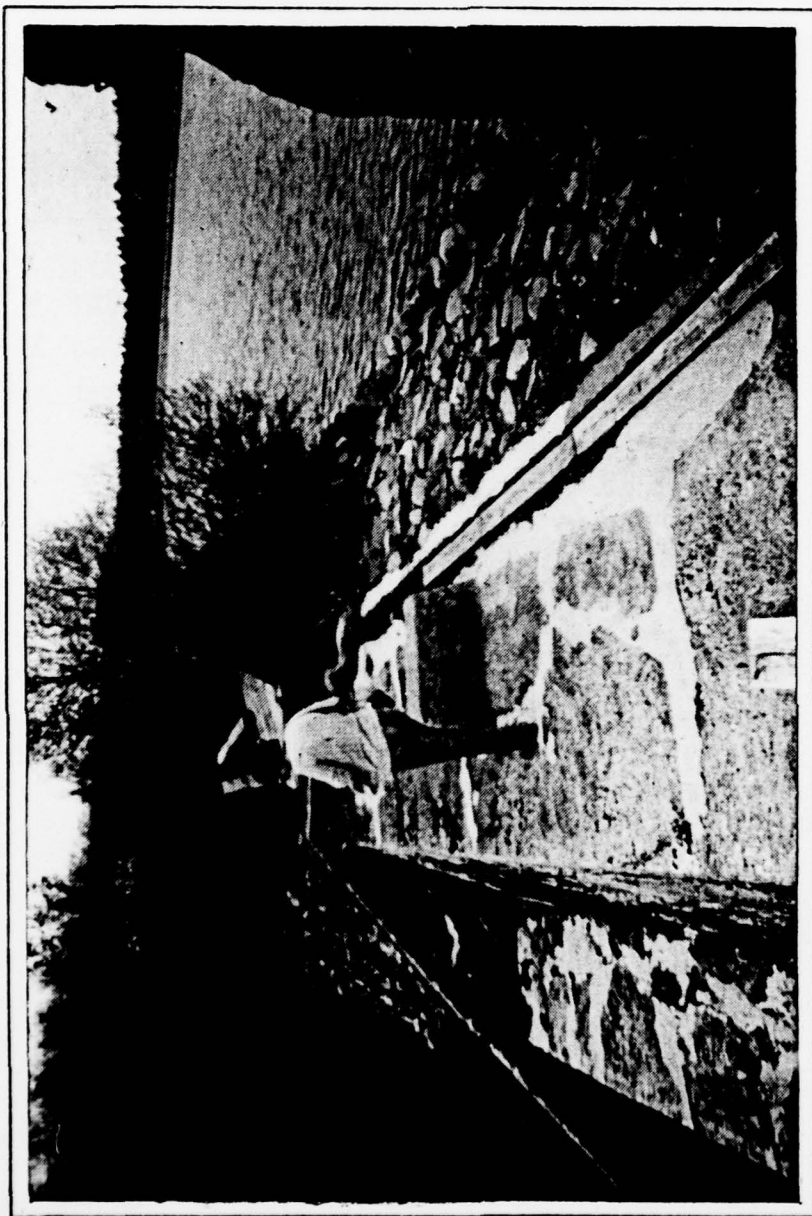
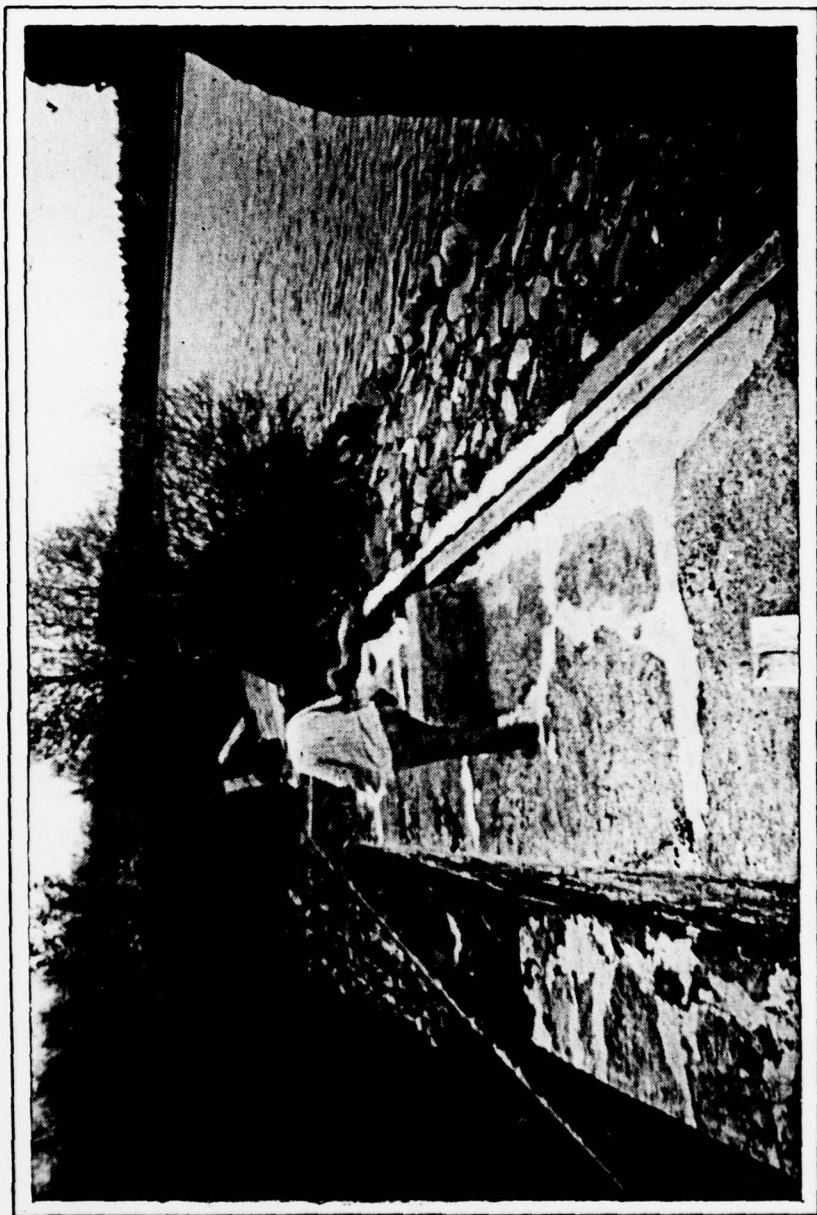
PHOTOGRAPH NO. 19

VIEW OF LYNCHWOOD LAKE DAM WHICH
DRAINS INTO STILLWATER LAKE DAM.
